# Forensic Engineering Newsletter

Volume III, Issue I

March 2009

## Why Underpinning is So Important

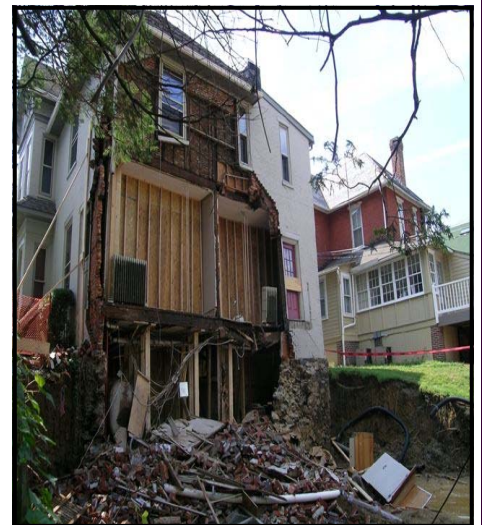
Such an excavation presents many challenges to be dealt with before the first bucketful of dirt is moved. First and foremost, a plan must be developed for the adjacent existing foundation to be underpinned to a depth equal to the depth of the foundation for the new construction. This requires the soil beneath the existing foundation be removed and replaced with a constructed element, such as a concrete wall. The soil beneath the entire length of an existing wall cannot be removed without the existing foundation collapsing. Therefore, underpinning is accomplished in sections, sometimes as little as two feet at a time, while the remainder of the foundation remains supported by soil or by previously constructed sections of underpinning. Failures often occur when a contractor does not underpin or elects to underpin a section of the existing foundation that is too long to support itself. The proper length of each section is a factor of the soil conditions and the strength and integrity of the existing foundation.

Another challenge is the risk there will be a collapse during the process of excavating down to the bearing elevation of the existing foundation, before the underpinning is initiated. The probability of this type of failure is high in older cities where the adjacent foundation wall may be 100 years or older. In the past, some foundations were constructed by digging a trench and filling it with rubble. This type of foundation has no inherent strength once the soil on one side is removed. Similar failures can occur in old stone masonry foundations where the mortar originally securing the individual stones has long since deteriorated.

“The City has recently experienced several building collapses attributed to builders digging basements and footings too close to existing buildings. In particular, many older buildings in Philadelphia are supported on rubble stone foundation walls with minimal or no spread footings below. When such walls are exposed or undermined they become unstable and are prone to sudden catastrophic failure. Building collapses have also been caused by property owners that attempt to increase the height of their basements by digging out the basement floor. Though the danger is most acute with rubble stone foundation walls, damage and failure can occur whenever structures are undermined, regardless of their age or condition. This Code Bulletin will set forth construction document requirements to aid in enforcing the code section that addresses this concern.”
